Thermal image building inspection for heat loss diagnosis

A. Preda¹ and I. C. Scurtu²

Abstract. Thermal imaging inspection for building applications it is powerful and non invasive method for monitoring and diagnosing the condition of buildings. With a thermal imaging camera you can identify problems early. This method allows us to check and correct issues before becoming more serious and more costly. By this method, we can exemplify the heat loss through the surface of the building. Thermal imaging consists of scanning the building with infrared, using a special camera. The radiated heat leads to a temperature variation on the surface of the building element in which is embedded. This method, corroborated with the calculation of heat loss, provides a technical and economical solution for the problem of thermal discomfort in the building.

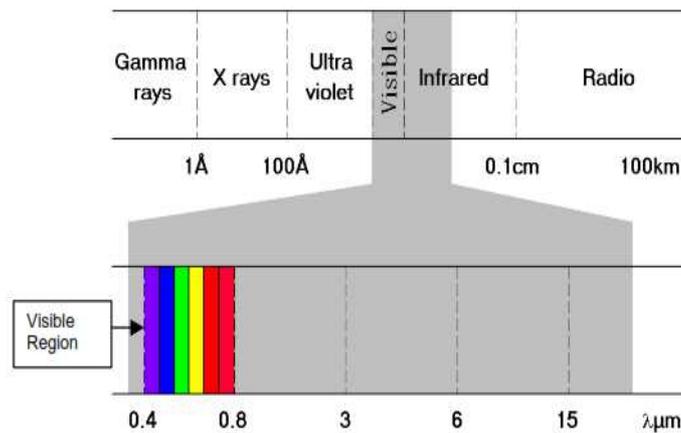
The energy from a heated object is radiated at different levels across the electromagnetic spectrum. In most of the applications it is the energy radiated at infrared wavelengths which is used to determine the object's temperature. The next figure shows various forms of radiated energy in the electromagnetic spectrum including X-rays, Ultra Violet, Infrared and Radio. They are all emitted in the form of a wave and travel at the speed of light. The only difference between them is their wavelength, which is related to frequency [10].

Fig1. Infrared area of electromagnetic spectrum

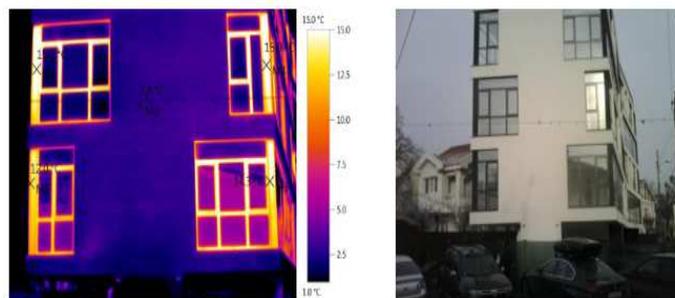
Fig. 2. South view of the building

In figure 2 we can see a thermal image of the south façade of the building where the average temperature on the wall is $+24\text{ }^{\circ}\text{C}$. There are some small places where the heat signature is increased due to outside factors not internal ones.

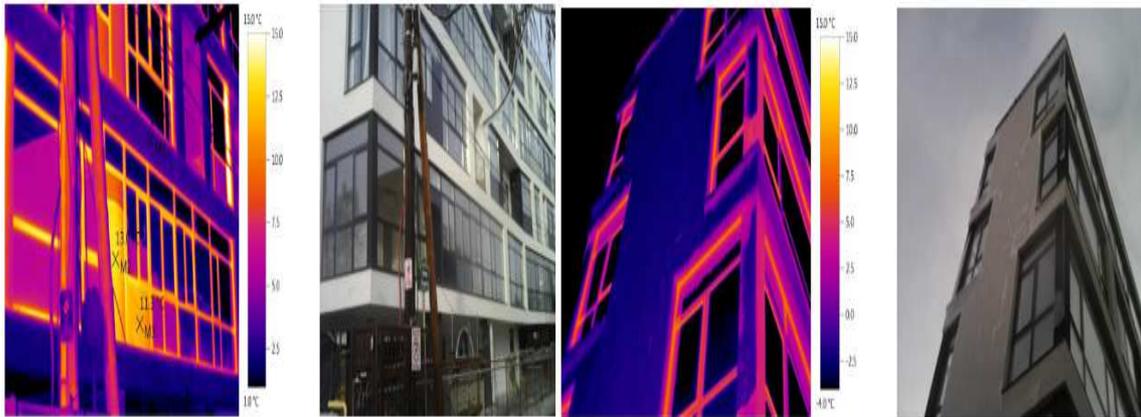
Fig. 3. East facade and south-east corner of the building

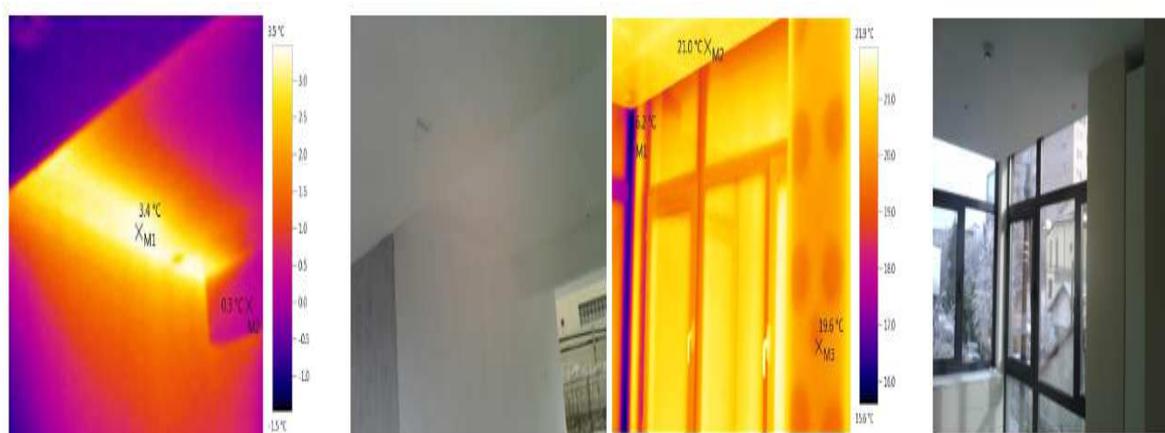
Fig. 4. Open air garage – ground floor and inside curtain wall

This thermography was done both externally and internally as a result of the owner's notification to determine the places with the greatest heat loss. As you can see, the plate above the ground floor has not been properly insulated and there is a heat loss that can become significant over time. The temperature indicates $3,4^{\circ}\text{C}$ on the exterior joint comparing with the next one of $0,3\text{ }^{\circ}\text{C}$. It is clearly that the insulation in that part is poor or does not exist. Taking a few inside pictures we realised the interior works were done properly only a few small things are due to be redone ore replaced.

Because the owner had a cold sensation while living in the building we had to take more picture and to reveal that the problem comes from the disposal of the air-heating elements. The air from the convectors does not cover all the aria of the windows, leaving some of them totally uncovered which produce this cold sensation even when the temperature reaches $20\text{-}21\text{ }^{\circ}\text{C}$.

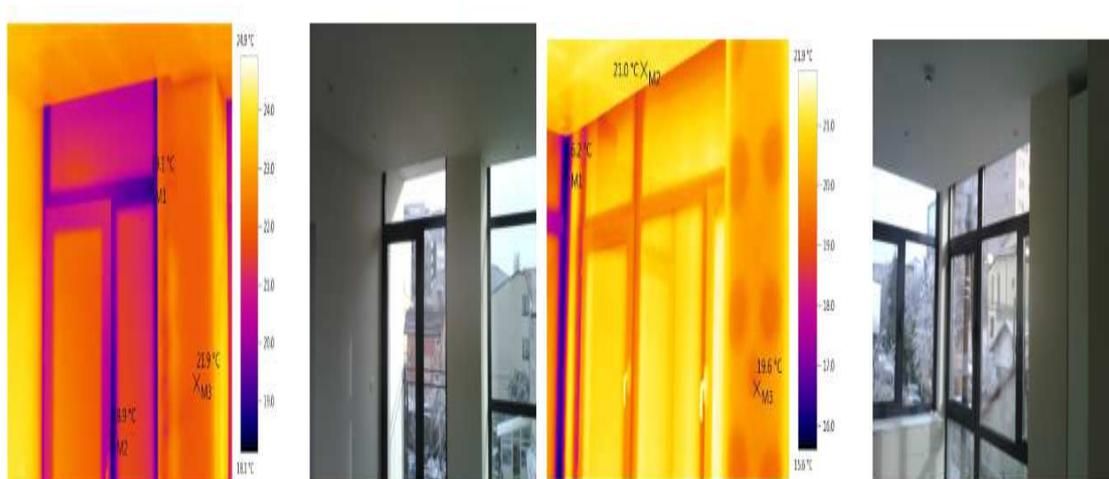
Fig. 5. Inside- 3rd floor south window

The top floor of the building show as a very good insulation of the rooftop but a poor quality of the frames and glass. We recommend the owner to change them with other with a better quality. At least 5 rooms for the frame and three layers of glass.

During the summer, to minimize heat inputs, has two corroborating ways. First is to apply a transparent film that resumes some of the ultraviolet but lets the light penetrate into the room and the second one, which leads to installation of curtains in most of the rooms.

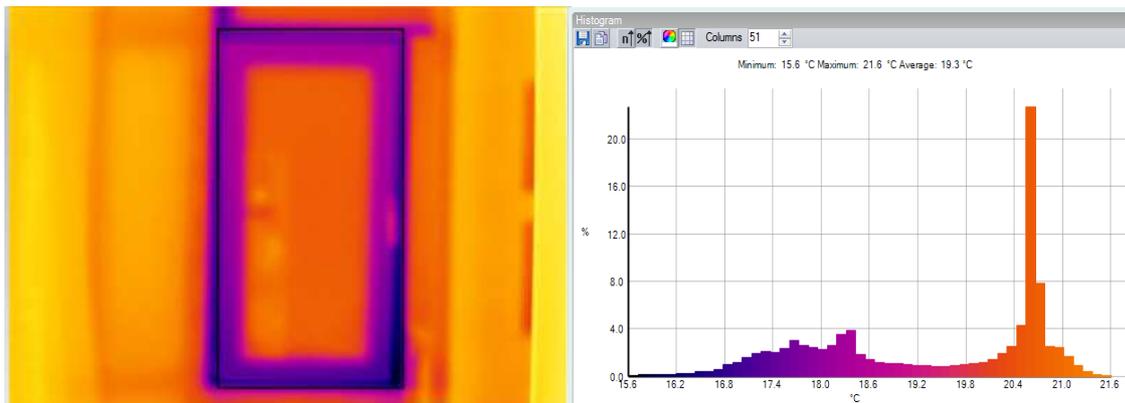
To determine the average interior temperature of an arbitrary window, a window has been averaged; the one in the bottom figure (the median was made in the rectangle that defines the window being analysed). The average value of camera software is 19.3 °C, value on the inside. The inside temperature considered was 22 °C.

Fig. 6. Determining the average temperature of a window on the inner face (inside the rectangle defining the window) in the left figure

To calculate the indoor and outdoor climatic conditions in which the thermal resistance of the window was measured, the following relationship is used:

$$R = 0.125 \frac{22-0}{22-19.3} = 1.01 \text{ m}^2 \text{ K/W}$$

The convective thermal resistance on the inside is 0.125 m² K / W, the internal temperature 22 °C, the outside temperature 0 °C and the average surface temperature 19.3 °C, determined previously. Typically, three layers of windows have around 1.2 m² K / W, thermal resistance, the determined value being close to value. This value is indicative of the measurement errors of the used method, so it is only advisory and does not take into account a measurement in the laboratory, in the climatic cell in which the internal conditions are stable and constant, according to the norms and standards under which it is measured of carpentry.

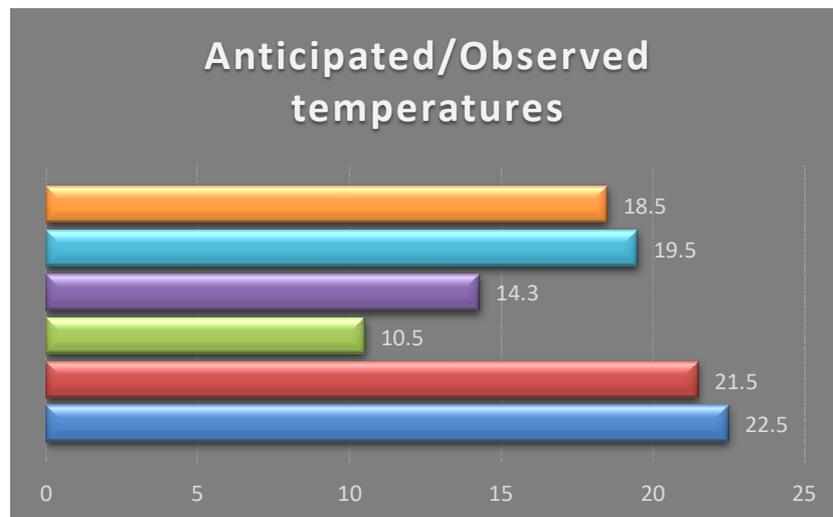
Walls			Windows			Doors		
Anticipated values	21.8	22	22.5	10	10.5	10.5	19	19.2	19.5
Observed values	18	21	21.5	11	13.2	14.3	17.8	18	18.5

Fig 7. Observed & estimated temperature chart

In our case, whole differences are less than 10 degrees Celsius. There are no major problems and most of all can be solved very rapidly.

If ΔT is between 1-10 – It is a minor problem . It is recommended to be solved within the next regular maintenance . This difference can be caused by moisture in 90 % of the cases.

If ΔT is between 10-15 – It is a average problem and a physical inspection it is needed. Must be fixed in the next maintenace.

If ΔT is between 15-20 or above - the problem becomes critical and needs intervation as soon as possible to fix it.
